HALEY & ALDRICH, INC.  
785 Ygnacio Valley Road  
Walnut Creek, CA 94596  
925.935.9771

31 January 2024

RE: Annual Observation Services  
Magee Ranch Open Space  
Danville, California  
CE&G Document 0207451-002

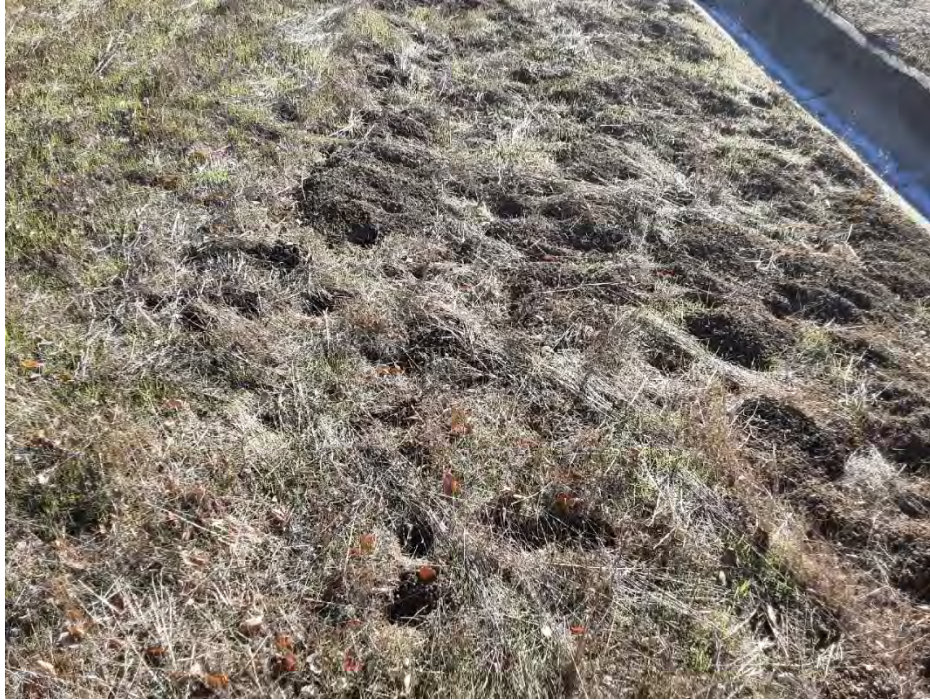
Photo 1. View of rodent burrows on the previously graded slope on the eastern side of Magee Ranch Road.

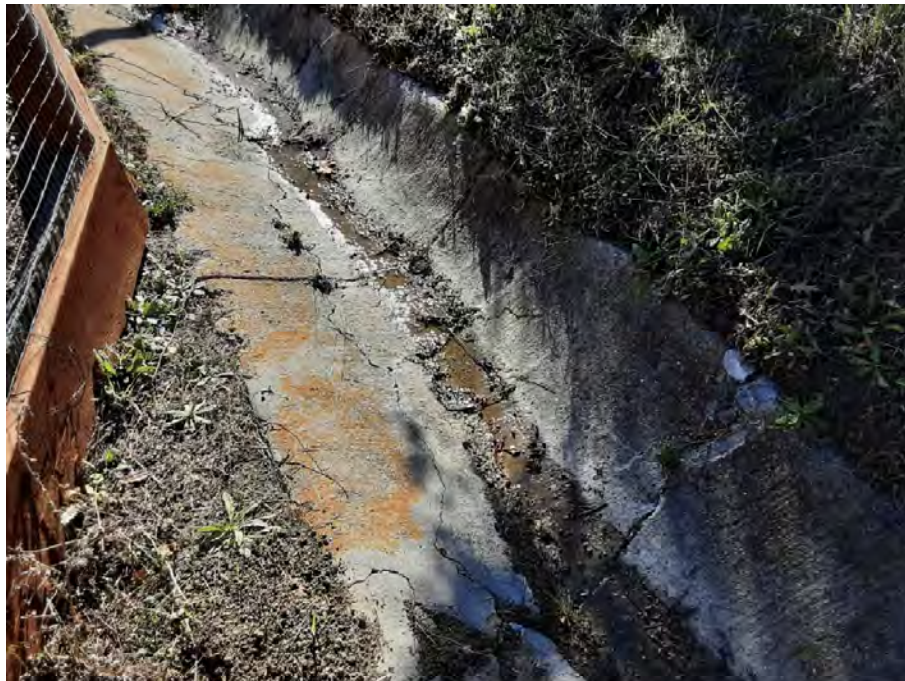
Photo 2. View of v-ditch with cracks and discharge from subdrain pipe.

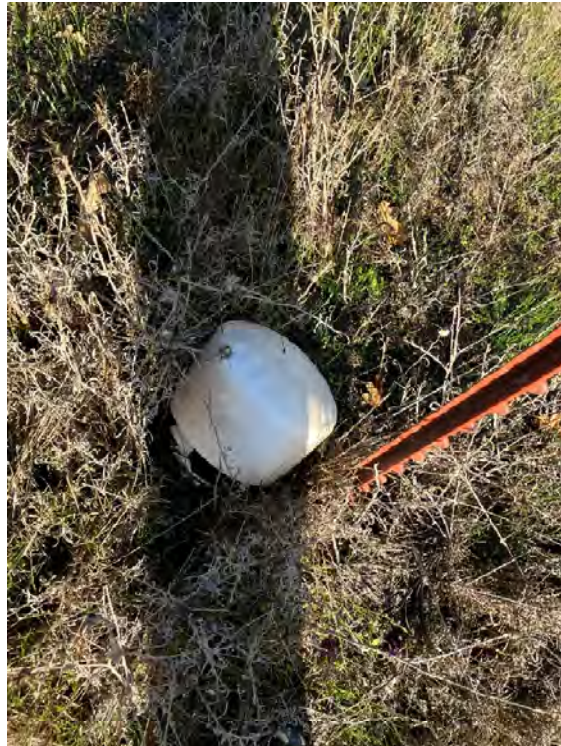
Photo 3. View of a damaged subdrain cleanout riser.

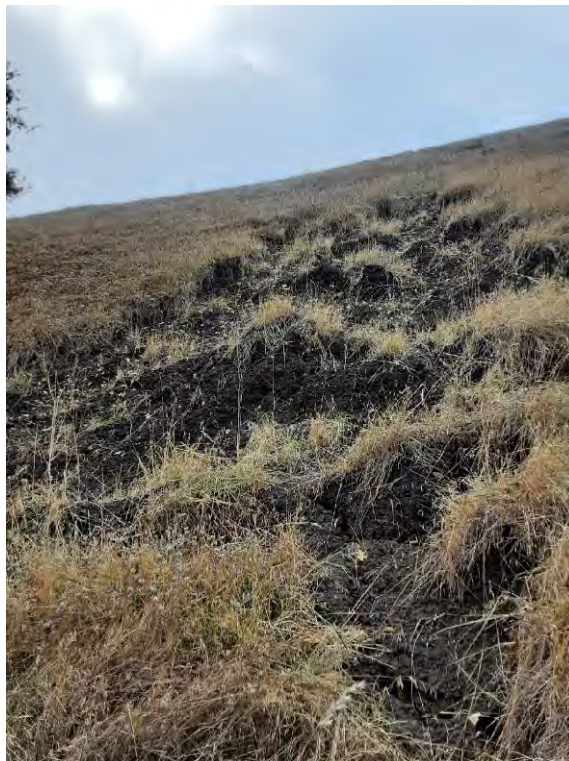
We did not observe readily identifiable evidence of reactivation of the previously repaired slide areas. It should be noted that during our December 2023 site reconnaissance, we mapped a small, surficial landslide above the previous failure repair behind 15 Brightwood Circle (Photo 4). Our observations indicated that the overall repair is stable, and deeper-seated movement was not observed.

Photo 4. View of recently active landslide above repair behind 15 Brightwood Circle.

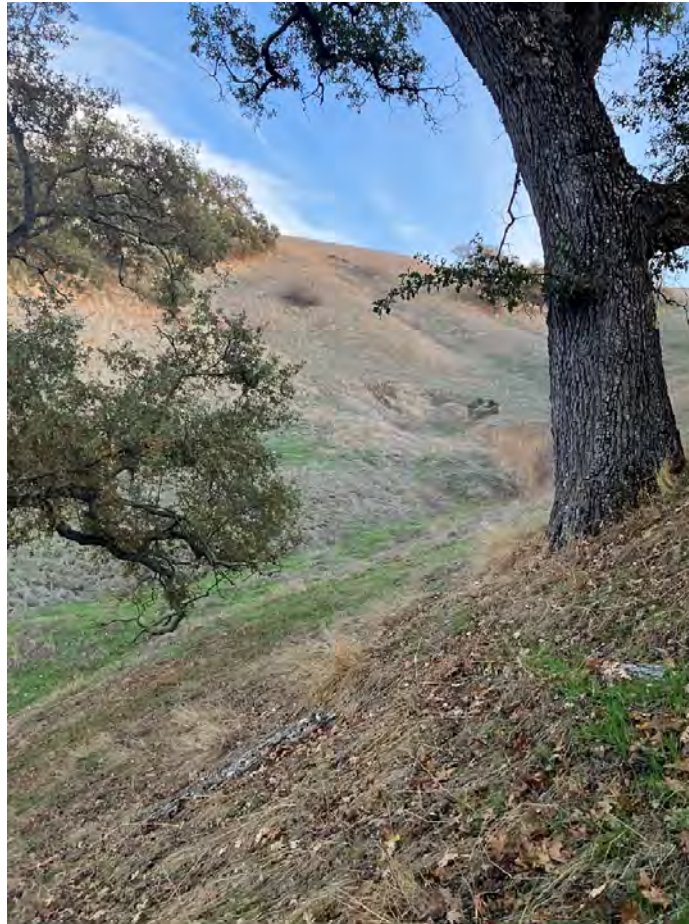
It should be noted that we have identified evidence of recent shallow landsliding in the drainage area east of Windover Drive near the gabion wall (Photo 5). Evidence of deeper-seated movement was not observed, and the gabion wall appeared to be in good condition.

Photo 5. View of recently active landslide in drainage area east of Windover Drive near gabion wall.

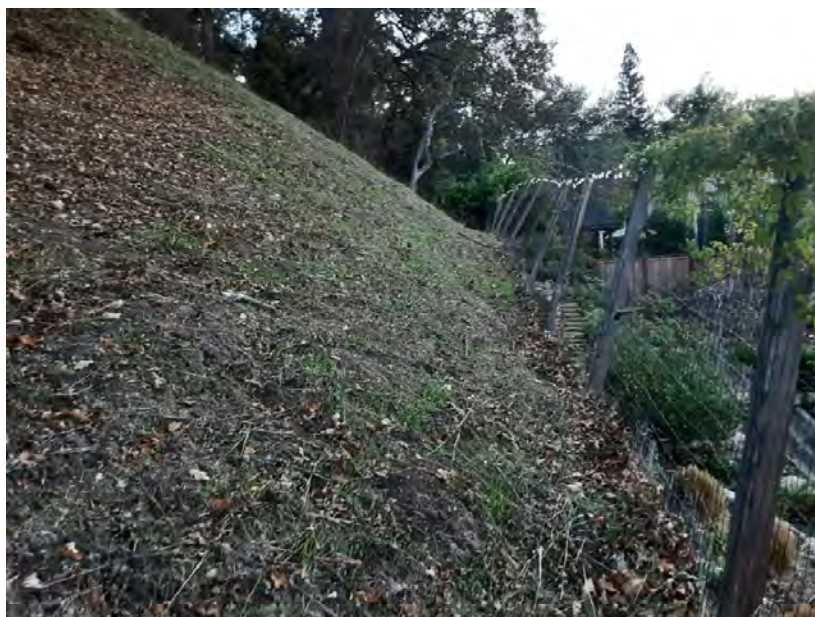
Photo 6. View of creep impacting the fence behind 120 Windover Drive.

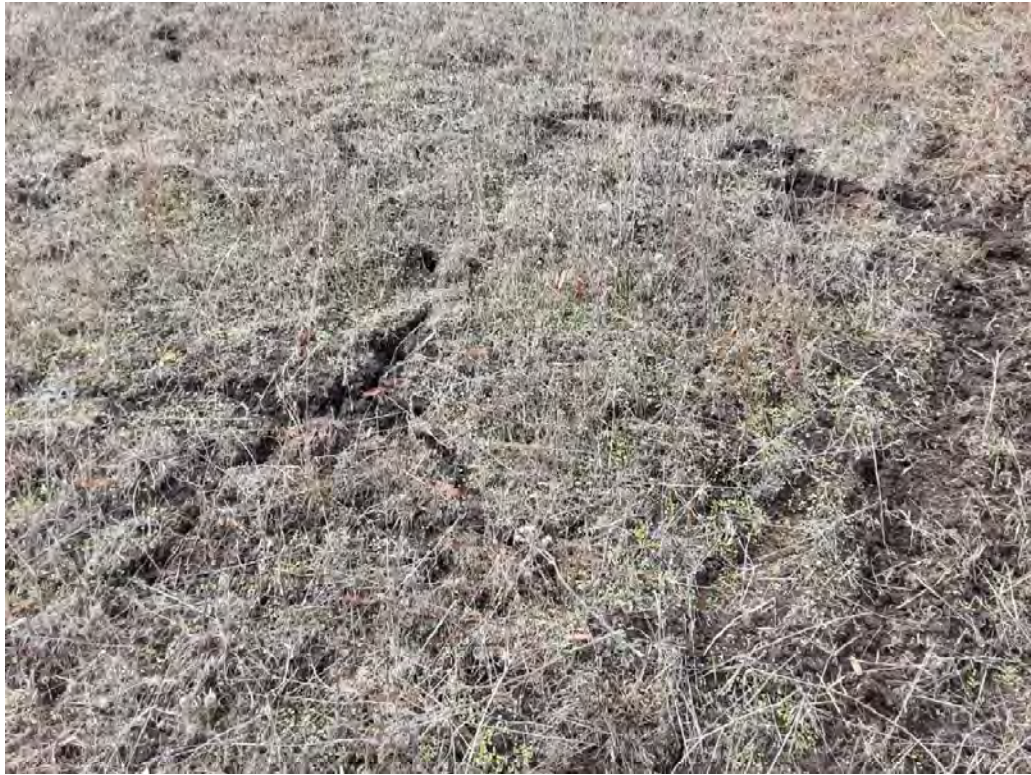
Photo 7. Soil cracks and creep observed behind 19 Maplewood Drive.

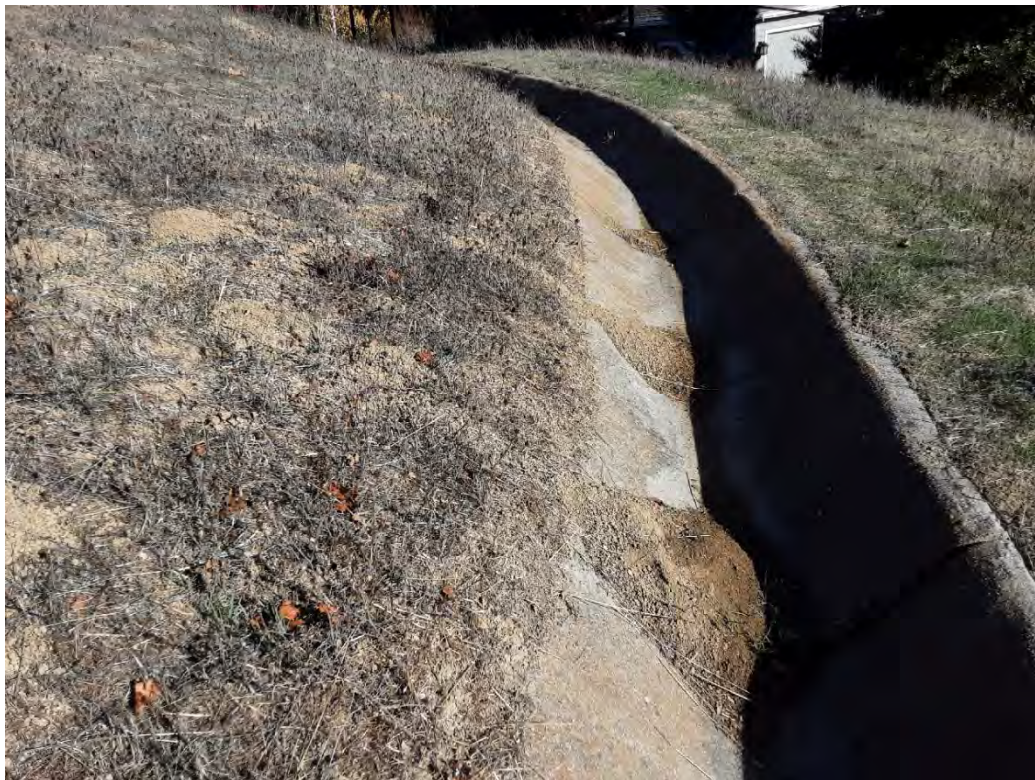
Photo 8. View of burrow holes depositing sediment into v-ditch behind 7 Crownridge Drive.

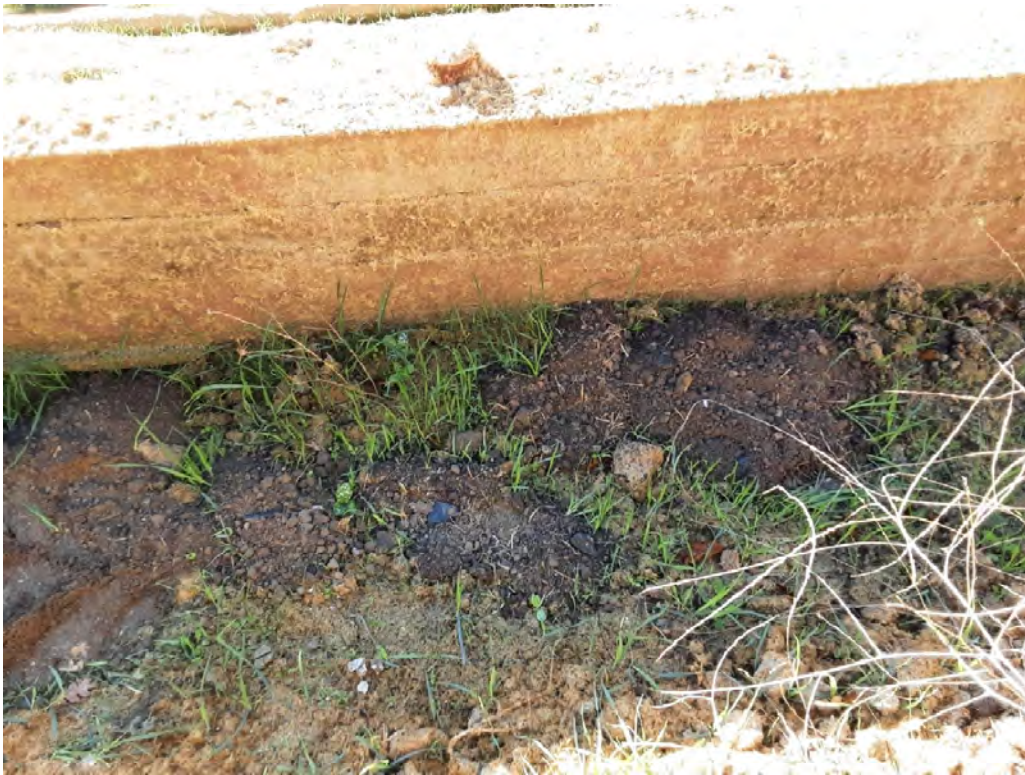
Burrows were also observed within the slope and at the base of the new wall constructed as part of the 2023 repair located above 155 and 158 Sunhaven Rd (Photo 9). These burrows can impact the long-term performance of the repair, undermine structures, and increase the potential for instabilities or increased debris mobilization and sedimentation. The continued undermining of the retaining wall will increase the potential for localized settlement and or destabilization of the soil below the wall.

Photo 9. Burrow holes observed at the base of the wood wall built as part of the repair behind 155 & 158 Sunhaven Road.

We recommend that areas where undermining of the v-ditches, drainage facilities, support structures, and previous slope repairs have occurred should be repaired. This may be accomplished by filing the burrow voids with the placement of neat cement grout or compacted soil.

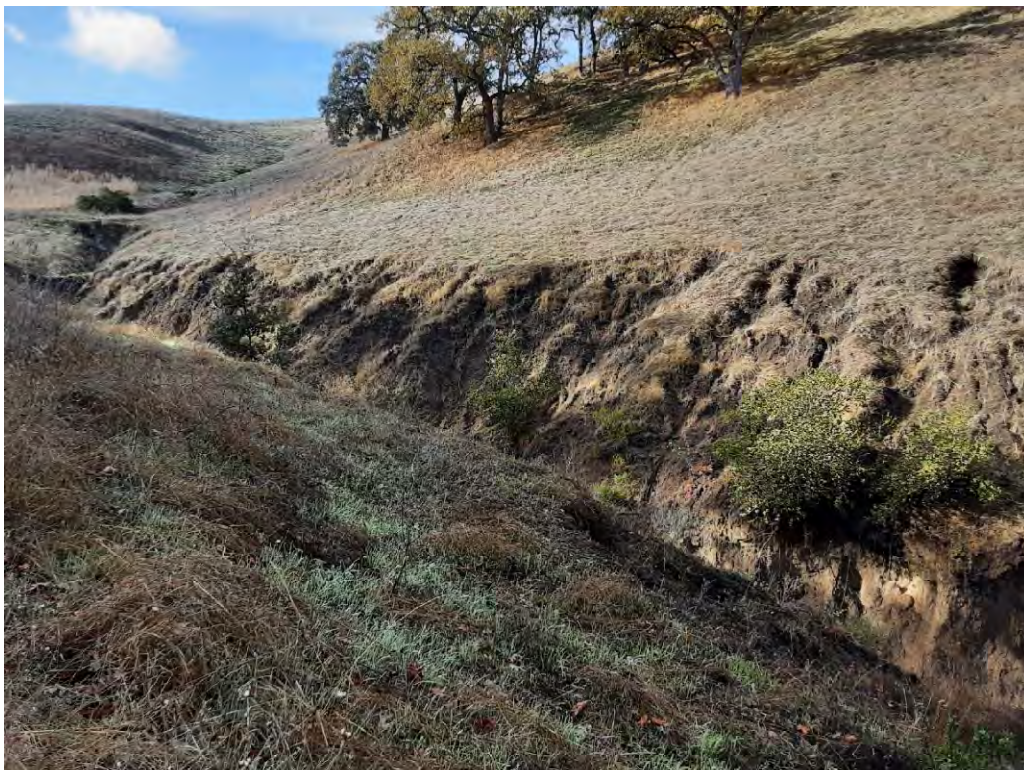
Photo 10. View of significant erosion in the ravine south of 138 Windover Drive.

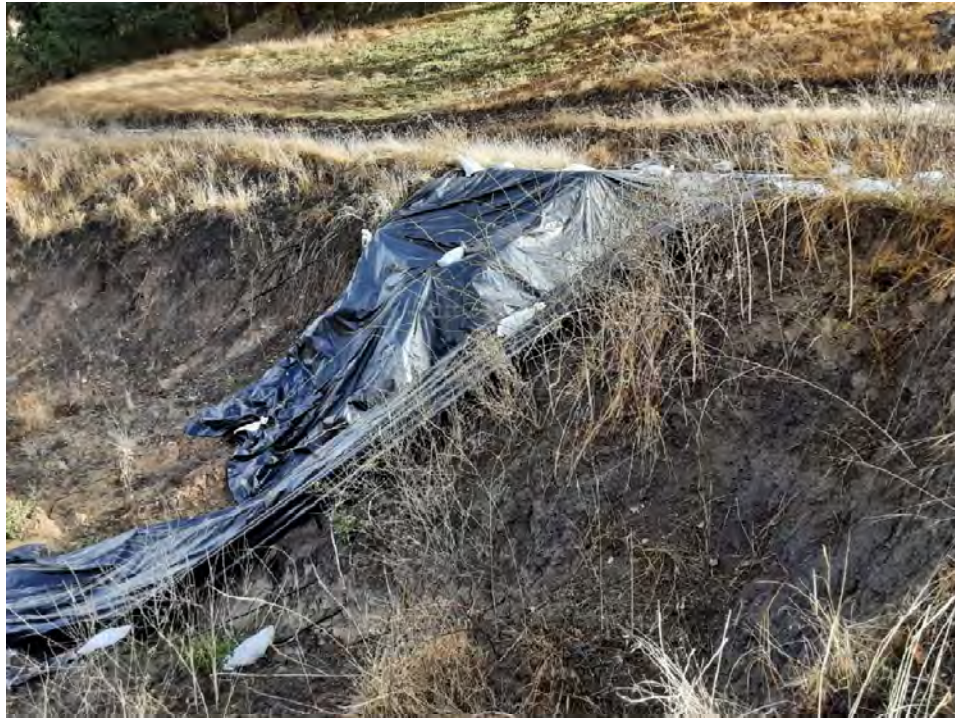
Photo 11. Slope failure on the eastern bank of the fire road south of 138 Windover Drive.

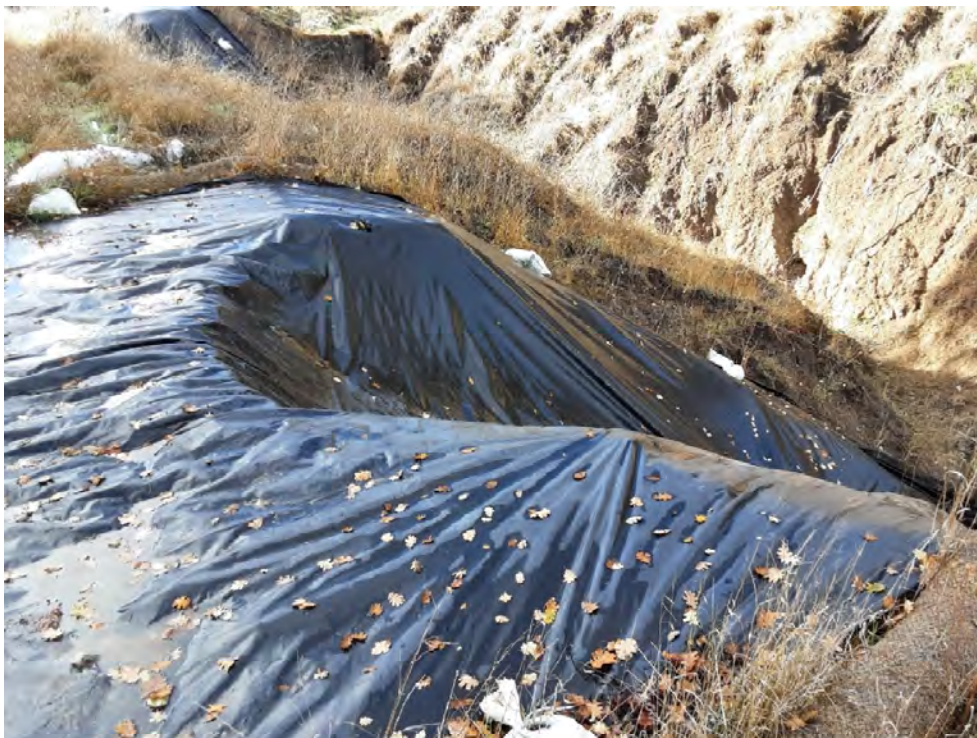
Photo 12. Slope failure on the eastern bank of the fire road south of 138 Windover Drive.

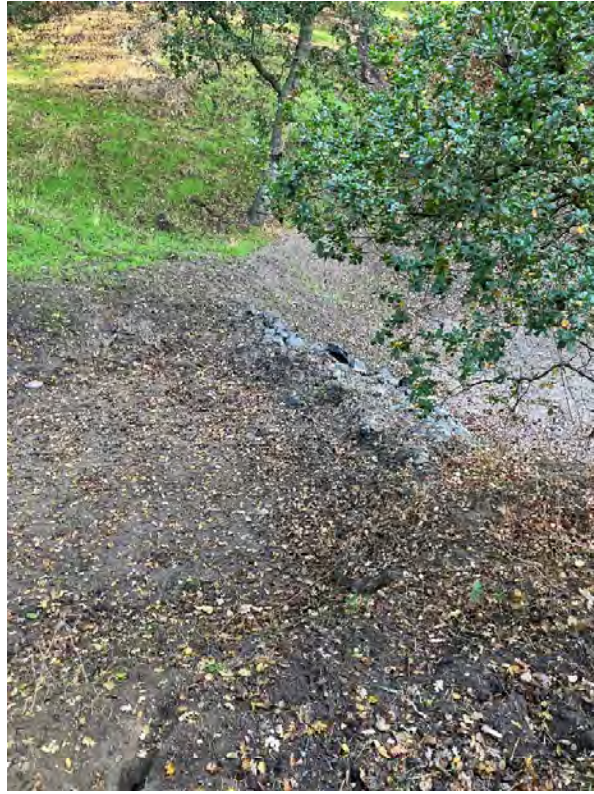
Photo 13. View of basin behind 138 Windover Drive at capacity.

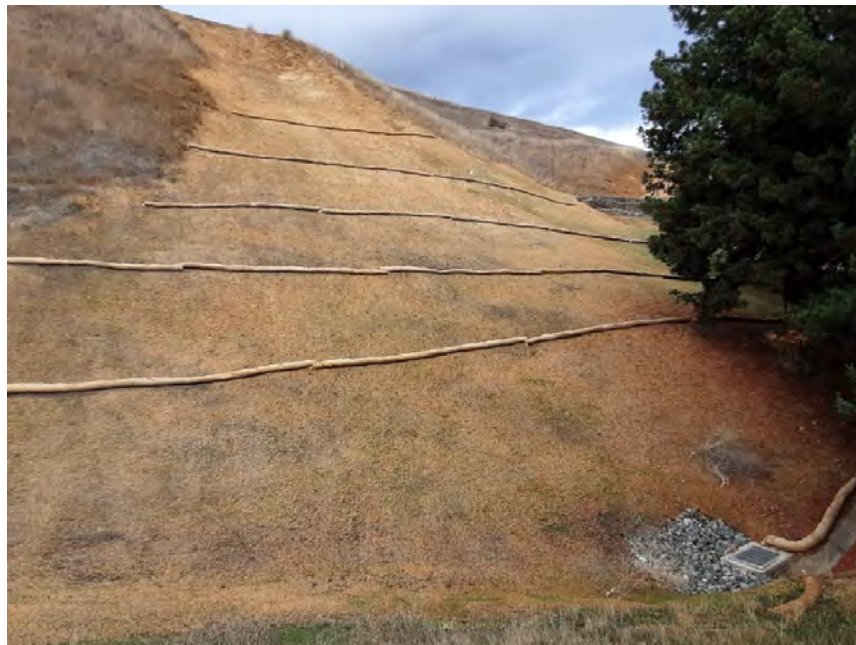
Photo 14. Repaired slope with hydroseed and drain rock behind 158 Sunhaven Road.

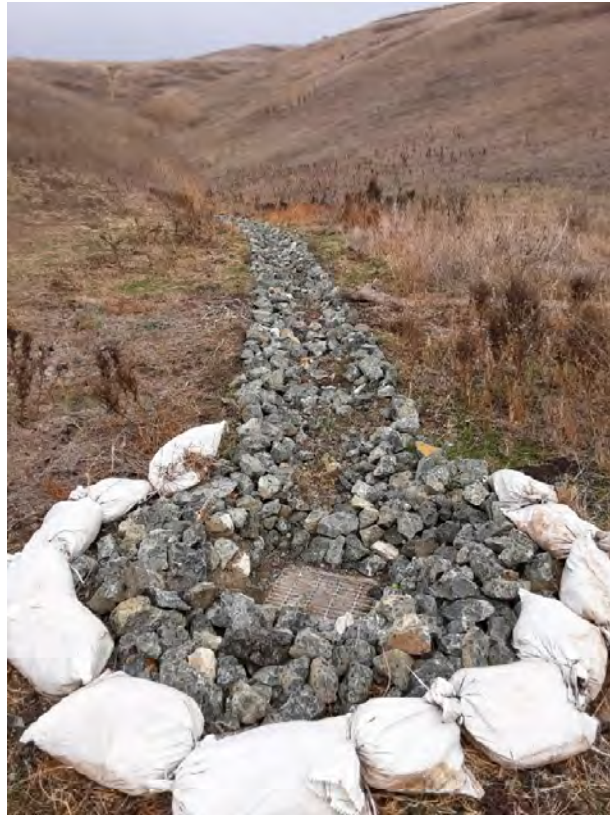
Photo 15. View of erosion repair with drain rock and new direct inlet on Sunhaven Trail.

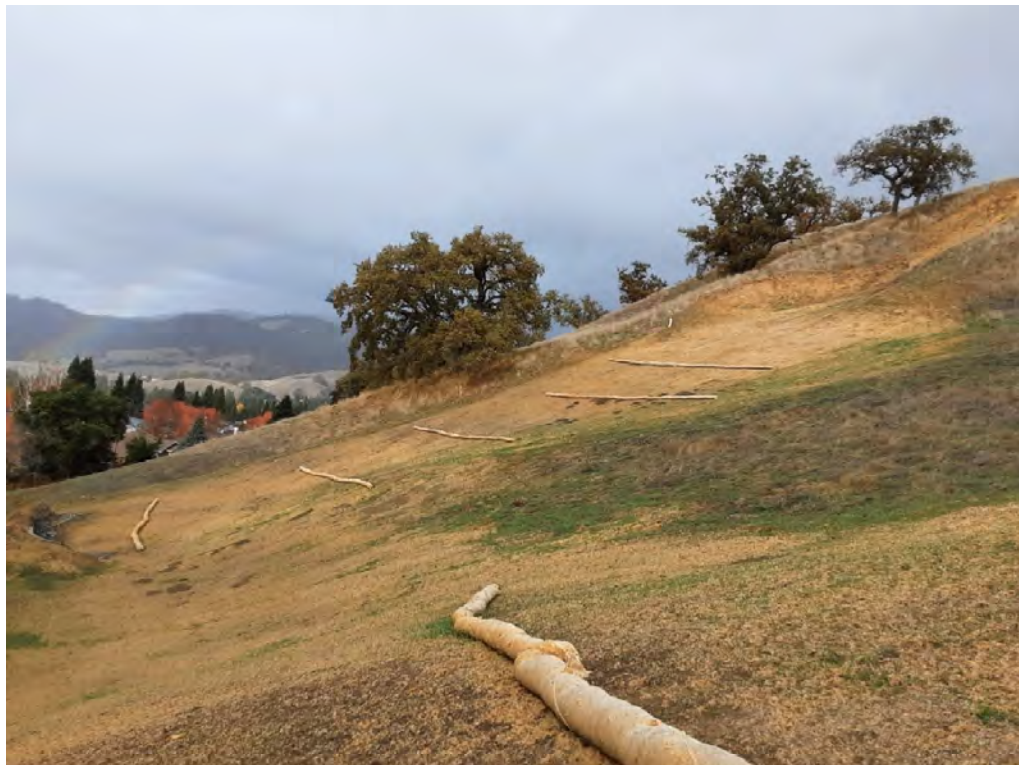
Photo 16. View of repair with new cleanouts and rockwall behind 116 Shadewell Drive.

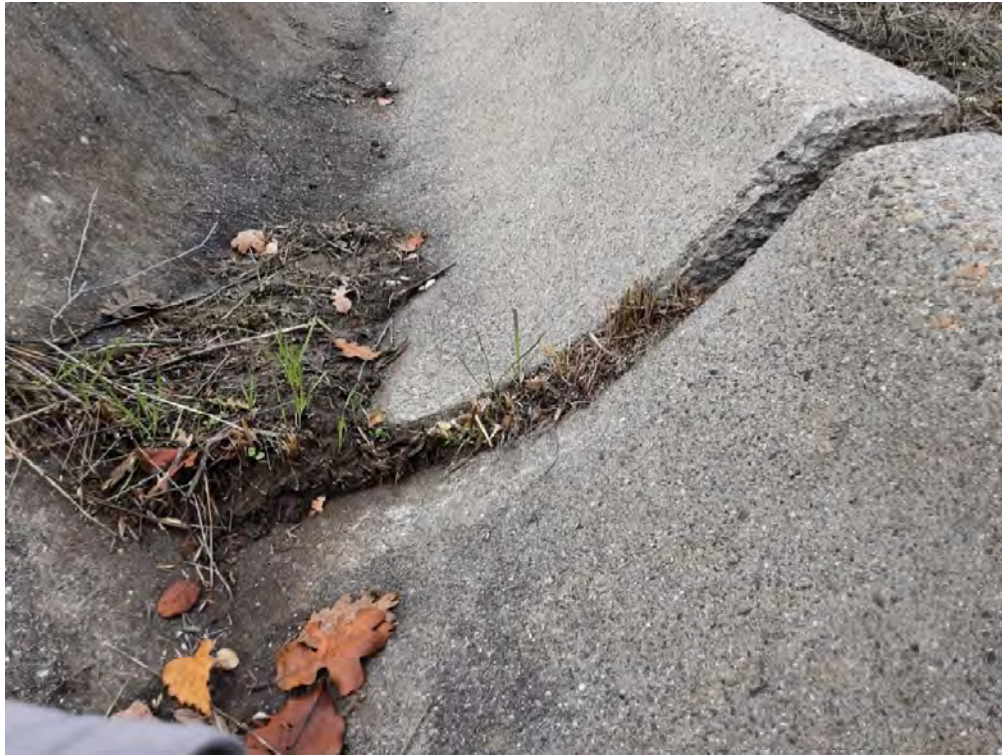
Photo 17. Vertical offset of 1.5 inches at v-ditch behind 25 Maplewood Drive.

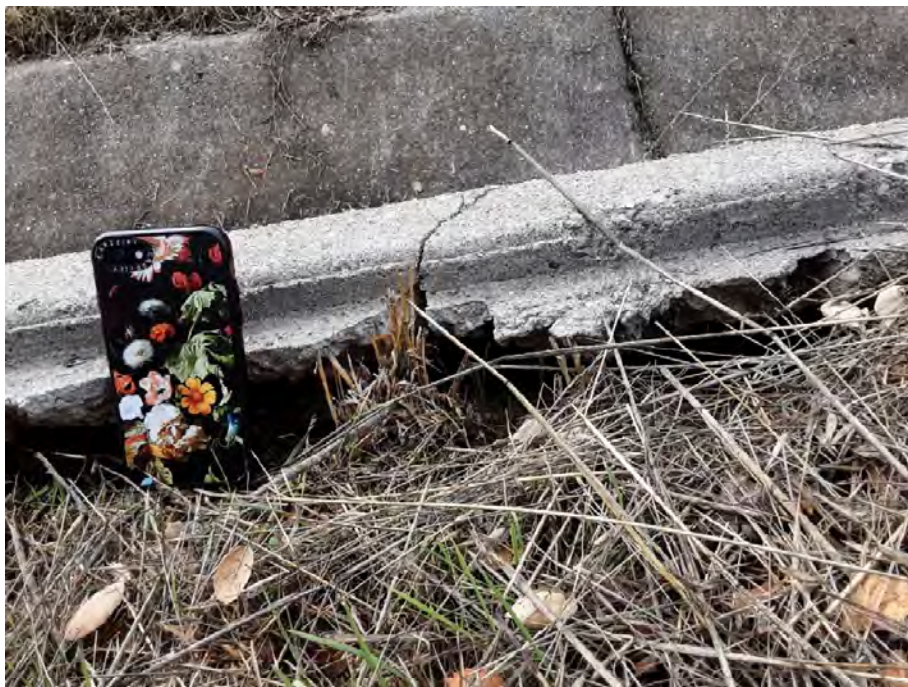
Photo 18. V-ditch lifted 2.5 to 3 inches and cracking from creep behind 25 Maplewood Drive.

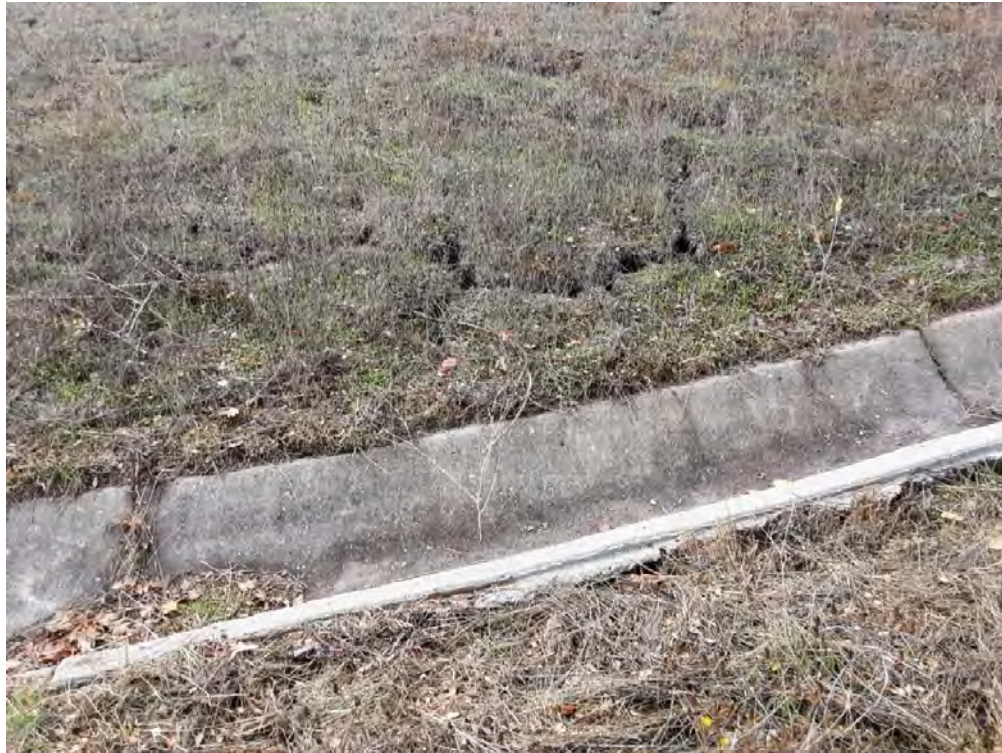
Photo 19. Soil cracks and creep impacting v-ditch behind 25 Maplewood Drive.

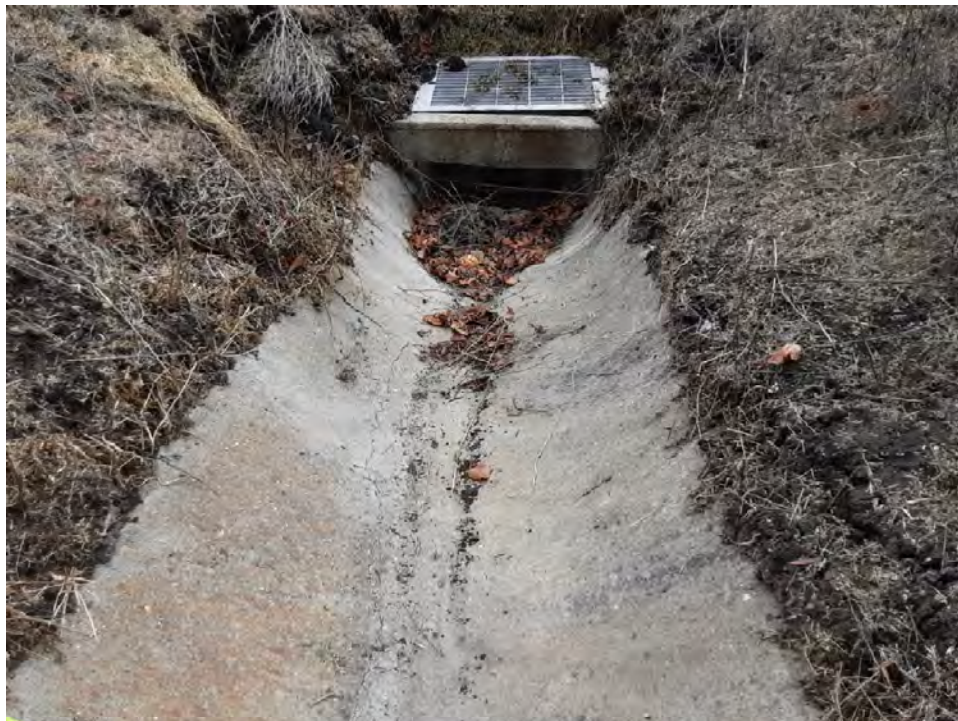
Photo 20. V-ditch and direct inlet behind 19 Maplewood Dr affected by creep, erosion, and debris deposition.

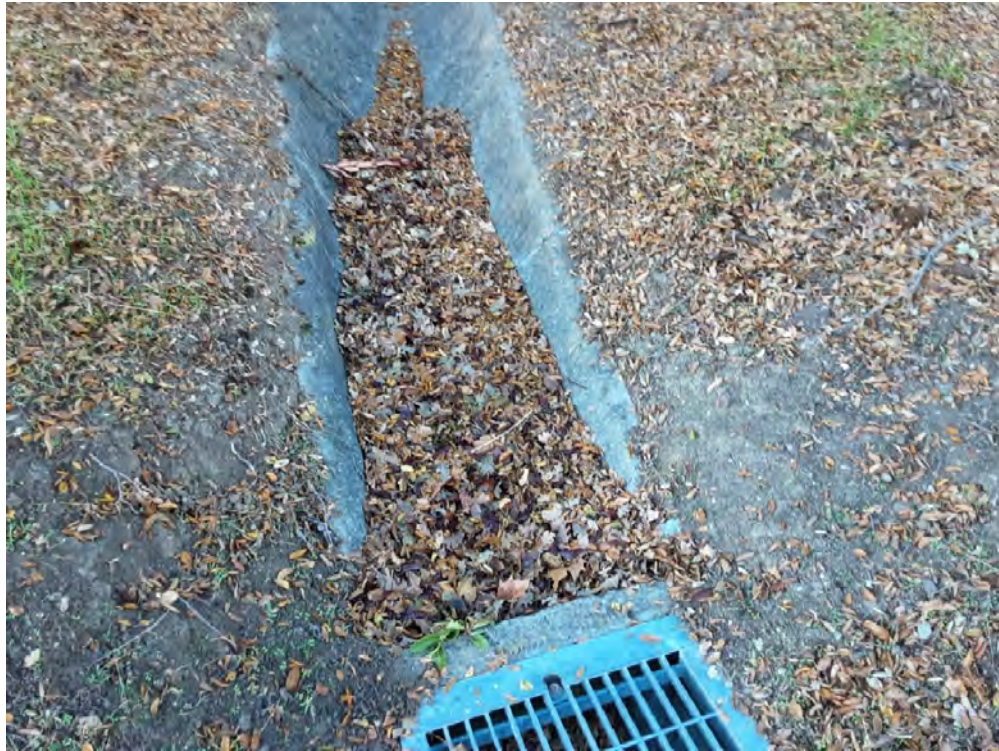
Photo 21. Debris blocking direct inlet at 154 Sunhaven Road.

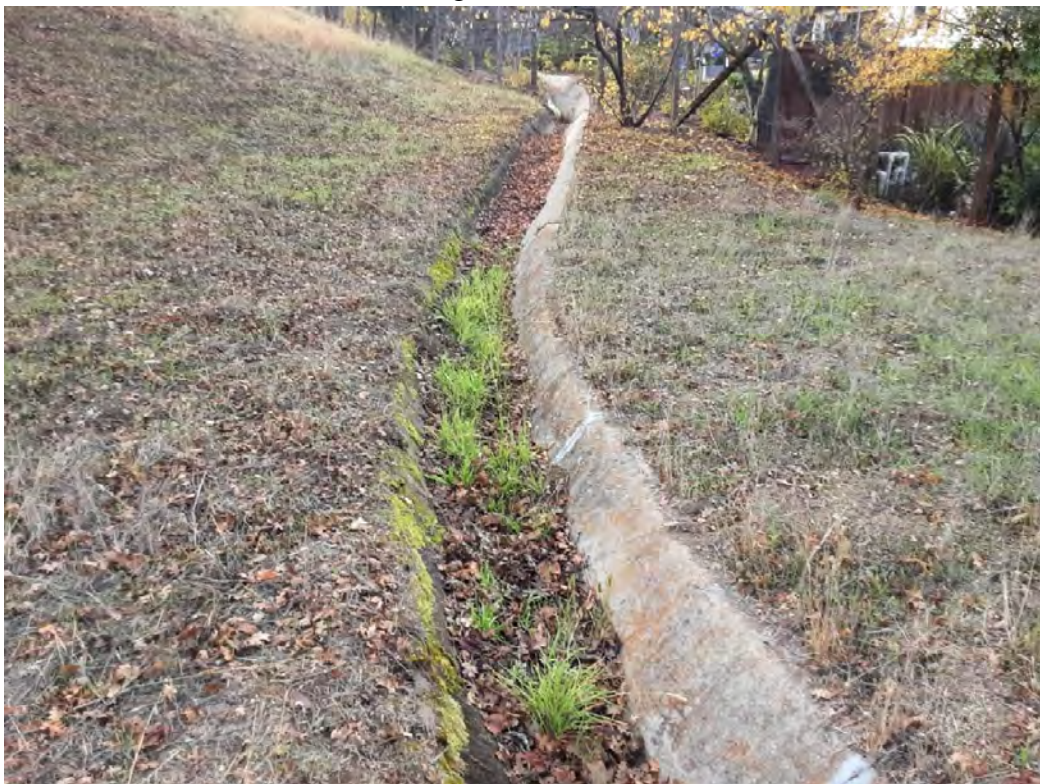
Photo 22. Significant amount of debris and grass growing in v-ditch behind 116 Leaffield Rd.
